Aviation Investigation Preliminary Report

Location:	Houston, TX	Accident Number:	DCA24FA120
Date & Time:	March 8, 2024, 07:58 Local	Registration:	N27290
Aircraft:	Boeing 737-8	Injuries:	166 None
Flight Conducted Under:	Part 121: Air carrier - Scheduled

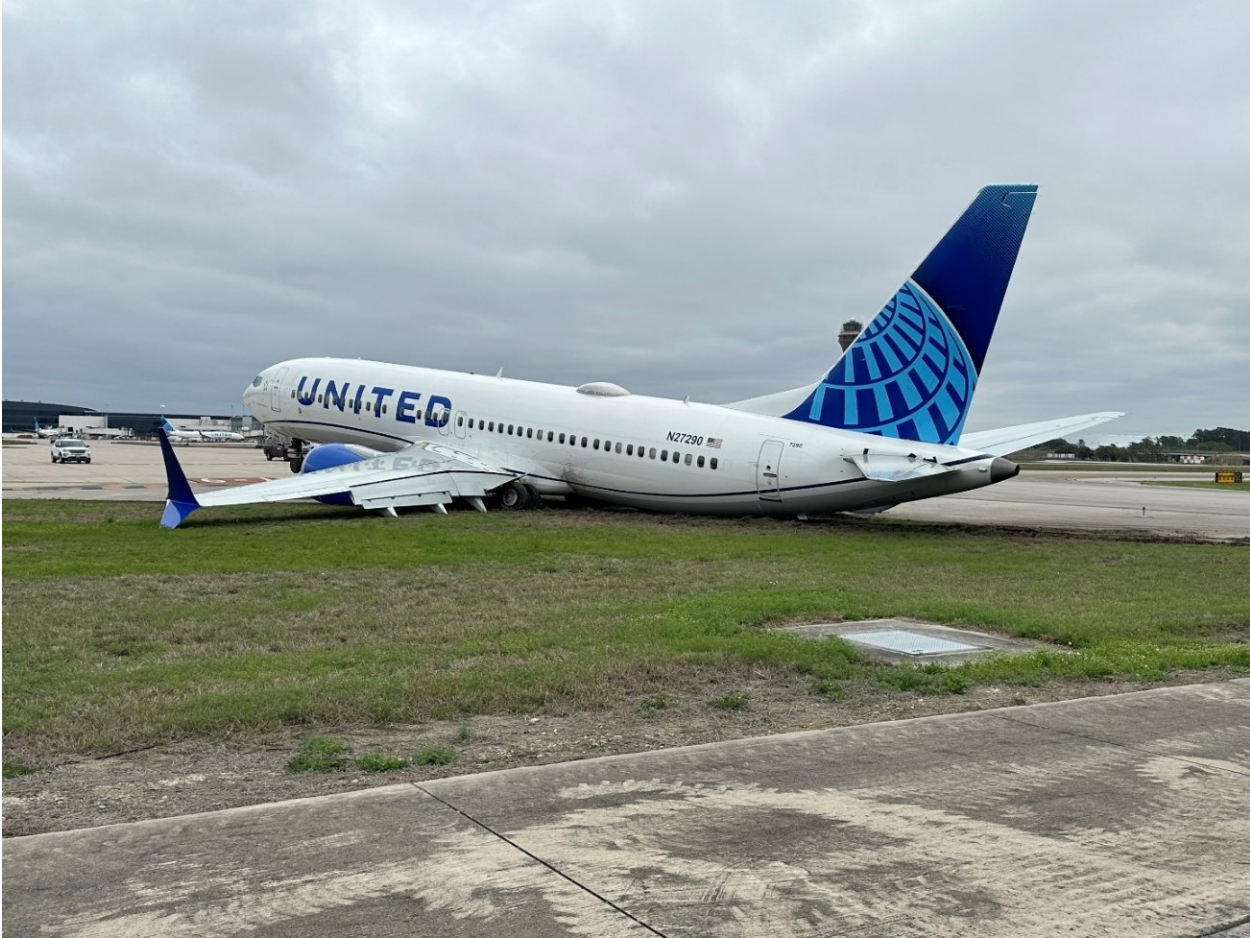
During the turn onto the taxiway, he felt the fuselage and rudder/brake pedals begin to shake violently. He briefly released the brake pressure and the shaking ceased. He then reapplied aggressive brake pressure and the shaking resumed. The airplane slid off the runway and the left MLG tires and nose wheels tires entered the grass before the airplane came to a rest with its left wing low.

Figure 1. Photograph showing the final resting position of the airplane.

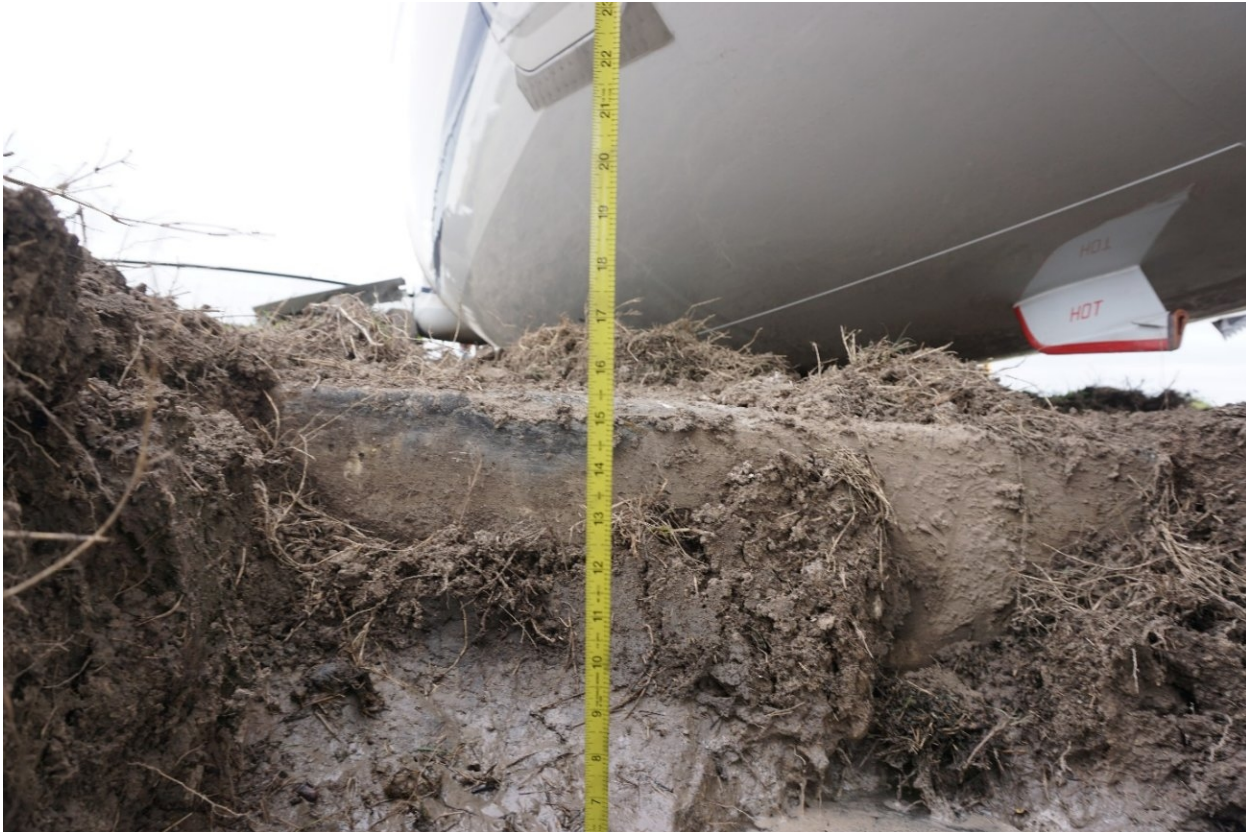
A postaccident examination of the accident site revealed that the left MLG tires had impacted a large concrete "manhole" designed as an electrical junction box for lights/utilities at the airport. As a result of the impact, the left MLG separated from the airplane at the fuse pins near the rear spar as designed to prevent more severe damage to surrounding structures. The airplane came to rest on the left engine nacelle, left winglet, and aft fuselage and sustained substantial damage to the left wing and aft fuselage.

Figure 2. Photograph showing concrete “manhole” impacted by left main landing gear. (Source: Boeing.)

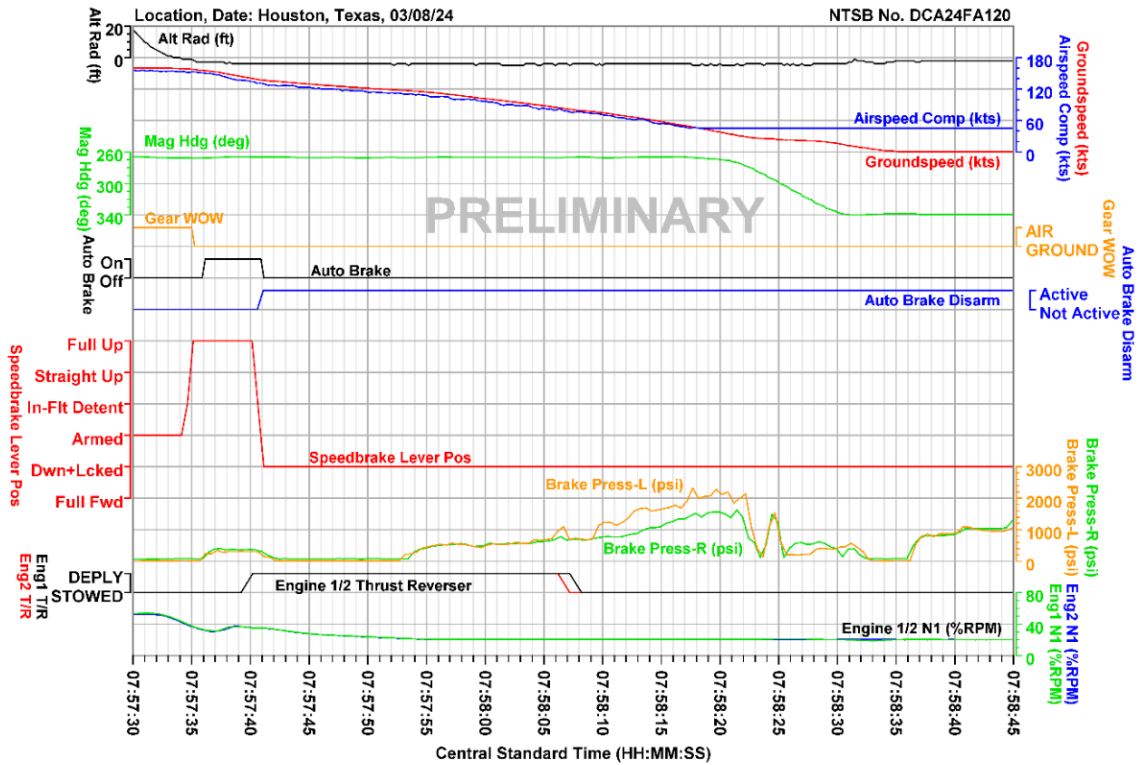
Data from the DFDR was sent to the NTSB’s Vehicle Recorder Laboratory in Washington, DC, for analysis. A preliminary review of data has been completed and a plot showing the braking parameters is shown in figure 3. Data showed that at touchdown the speed brake lever position [Speed Brake Lever Pos] and auto brake parameters were full up and on for about 5 seconds before transitioning to down and locked and off for the remainder of the landing rollout.

The engine thrust reversers were deployed for the left and right engines for about 27 and 26 seconds respectively at idle reverse. The left and right brake pressure increased to their maximum pressure consistent with aggressive manual braking before and as the airplane’s heading changed consistent with a right turn.

Figure 3. Plot of the FDR data from the accident landing.

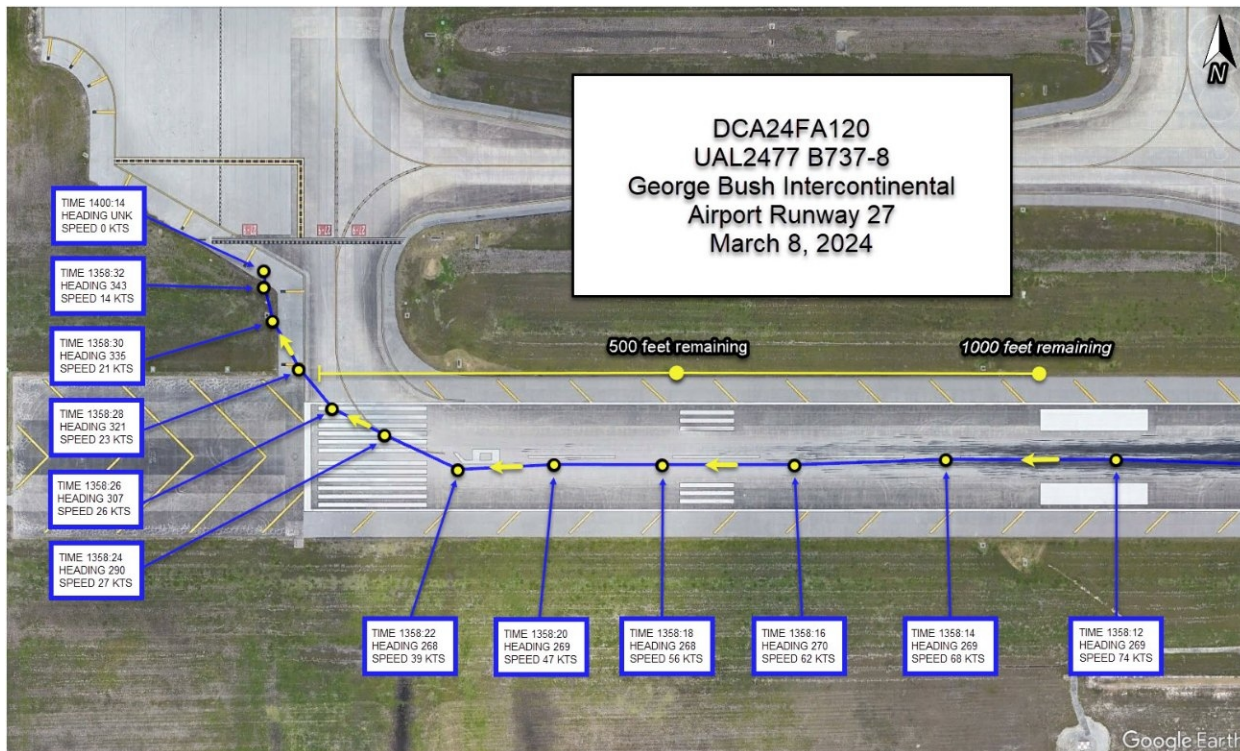
Certified ADS-B data, which records more accurate latitude and longitude data than the DFDR, was provided to the NTSB by the FAA. Analysis of the ADS-B and DFDR data shows that the airplane touched down about 1,000 feet from the runway threshold with a groundspeed of about 158 knots. With about 1,000 ft and 500 ft of runway remaining the airplane groundspeeds were about 72 kts and 57 kts respectively. The right turn to exit the runway was initiated at about 39 kts groundspeed and the aircraft departed the end of the paved surface at about 22 kts (figure 4).

Figure 4. Accident airplane’s landing rollout time, heading and speed from ADS-B data overlaid on a Google Earth image of runway 27 and taxiway SC at IAH. Yellow arrows indicate direction of travel.
