# **Aviation Investigation Preliminary Report**

Location:	Houston, TX	Accident Number:	DCA24FA017
Date & Time:	October 24, 2023, 15:20 Local	Registration:	N510HM (A1); N269AA (A2)
Aircraft:	TEXTRON AVIATION INC 510 (A1); RAYTHEON AIRCRAFT COMPANY HAWKER 850XP (A2)	Injuries:	4 None (A1); 3 None (A2)
Flight Conducted Under:	Part 91: General aviation - Personal (A1); Part 135: Air taxi & commuter - Non- scheduled (A2)

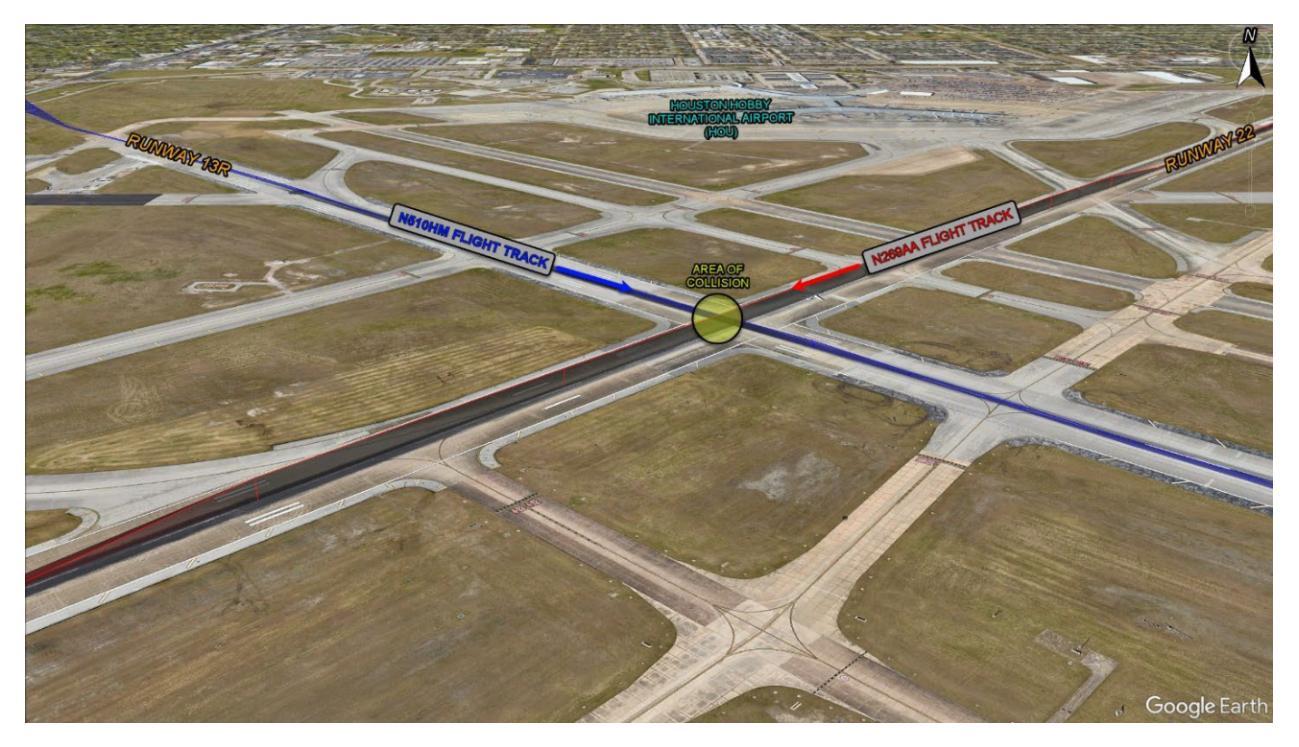
HOU has intersecting runways, and the local controller had instructed the crew of N269AA to line up and wait (LUAW) on runway 22. The crew of N269AA said in a post-accident interview that they believed they heard that they were cleared for takeoff when they took off. The collision between the two airplanes occurred at the intersection of the two runways, see figure 1.

**Figure 1.** View of both airplanes flight tracks with the area the ground collision occurred highlighted in yellow. The blue line represents N510HM, and the red line represents N269AA.

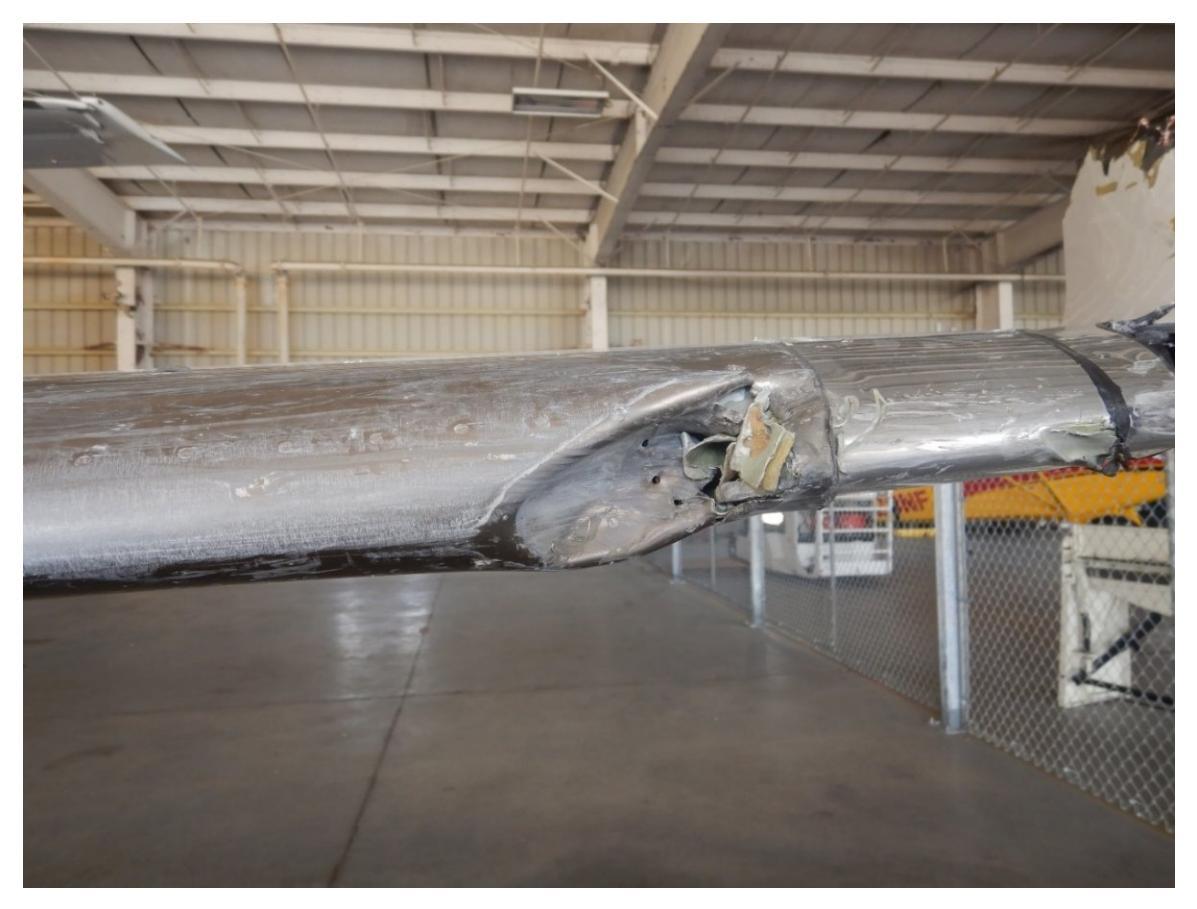
Post-accident examination of N269AA revealed that the left wing exhibited impact damage. The titanium leading-edge panel exhibited a "V-shape" aft indention to the wing front spar with sheet metal remnants of the Cessna Mustang embedded, see figure 2.

Figure 2. Close up view of N269AA's left-wing leading-edge damage.

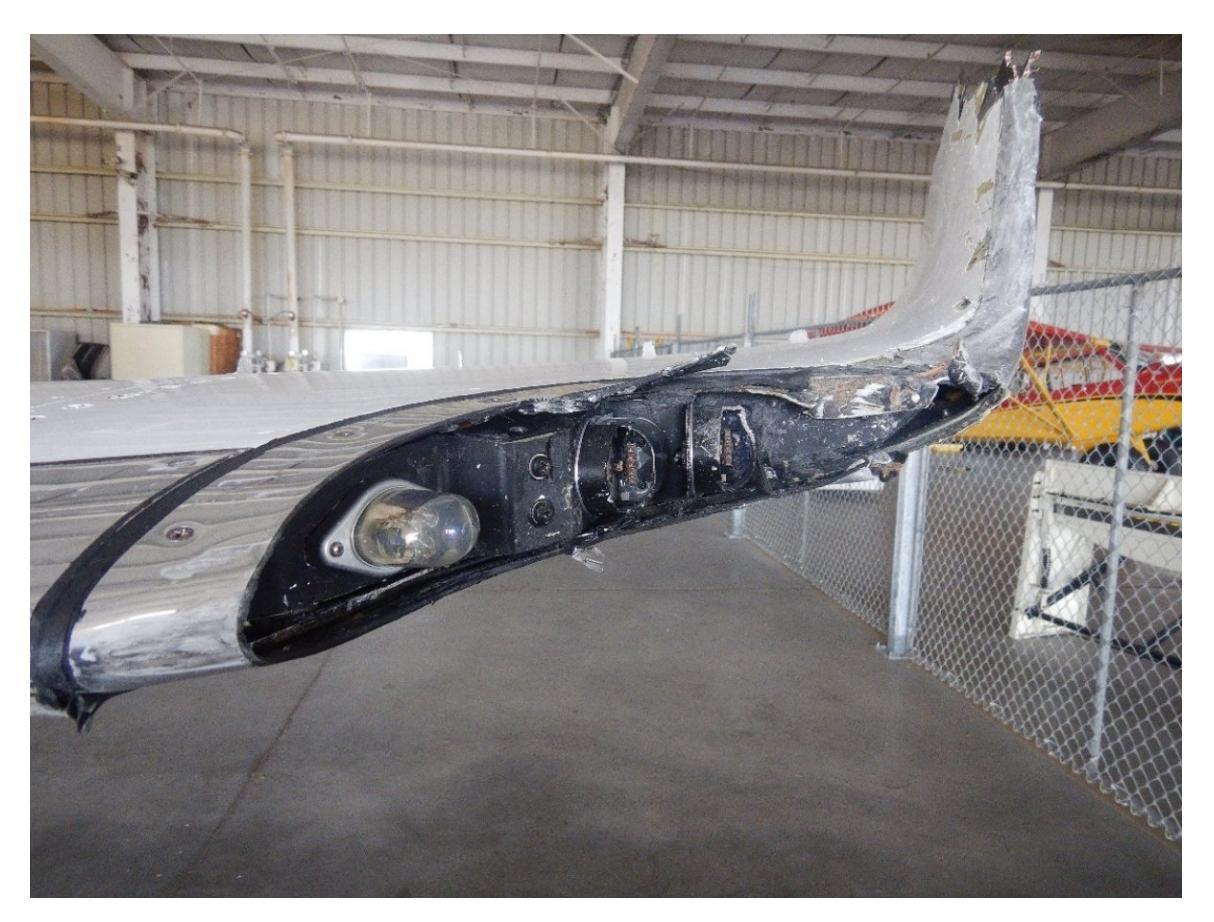
N269AA's left-wing winglet remained attached to the left wing. The winglet leading edge exhibited white paint transfer marks and the navigation light lens was impact separated and pieces of the glass were found in the Cessna Mustang's tail cone/stinger. About ten inches of

the top section of N269AA's winglet had separated due to the impact with N510HM, see figure 3.

Figure 3. Close up view of N269AA's left winglet/navigation light assembly damage.

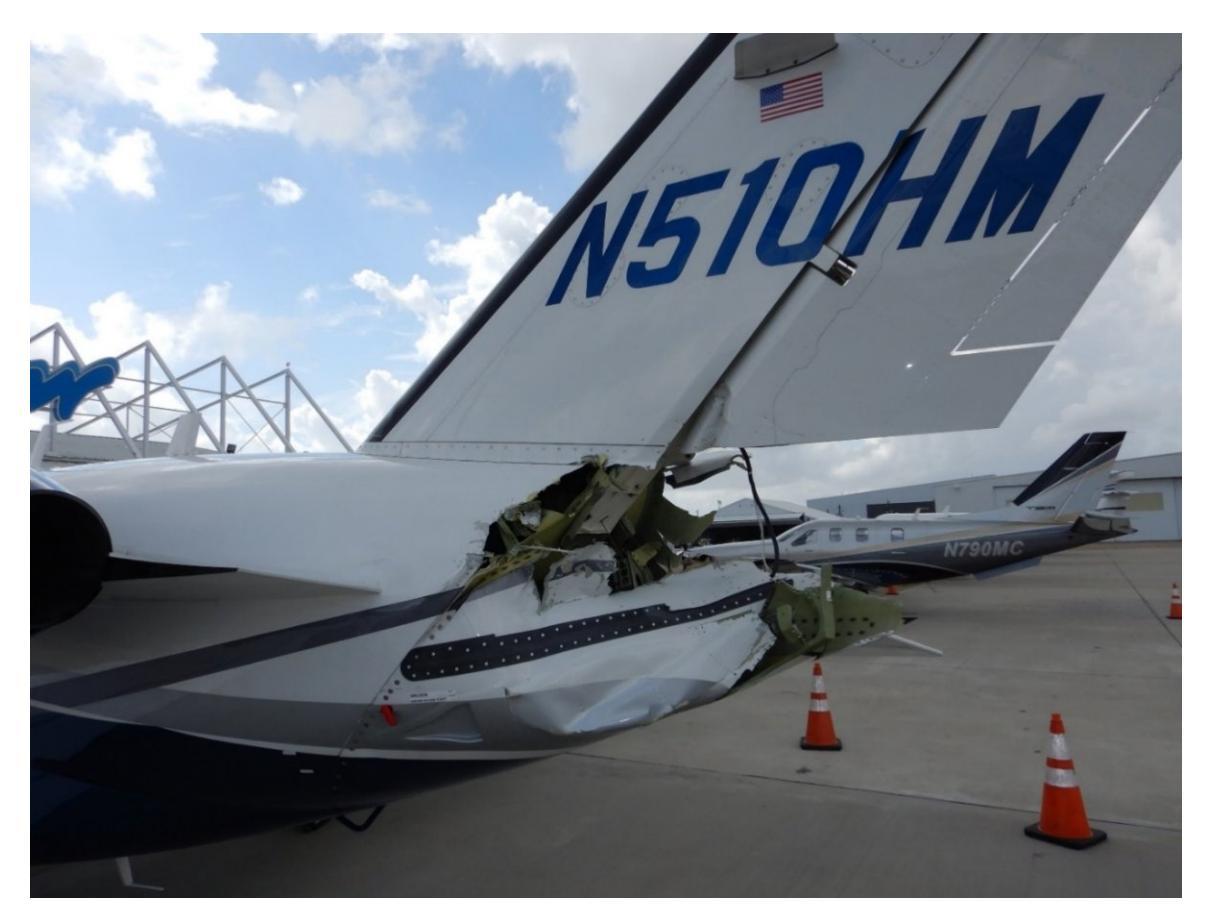
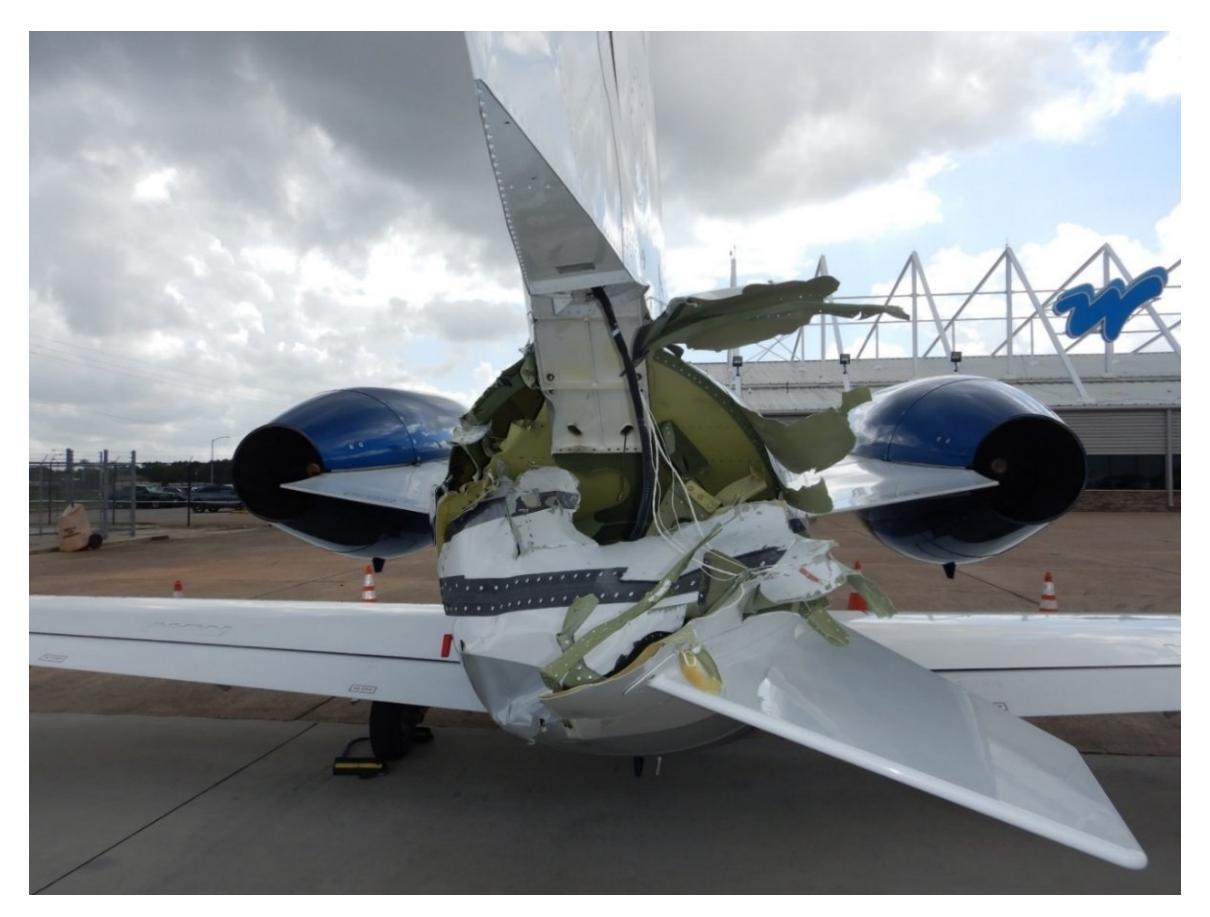
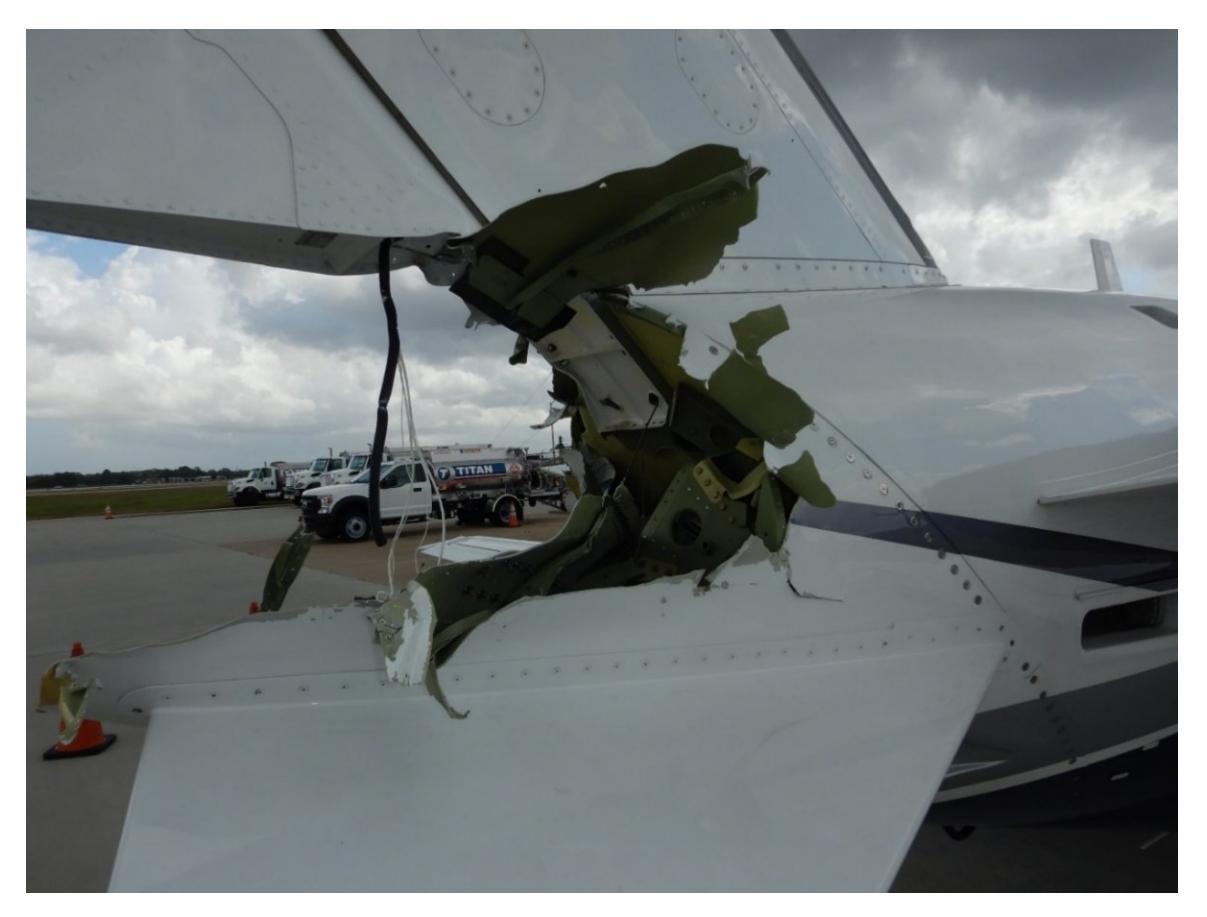
Post-crash examination of N510HM revealed that the left side of its tail section had been impacted by the left wing of N269AA. The torn skin on the tail section was consistent with N269AA's wing penetrating the left side of N510HM's tail stinger and exiting the right side, severing a portion of the stinger. The impact damage was isolated to the area of the empennage, see figures 4, 5 and 6.

The impact fractured and separated a section of the aft canted bulkhead. A section of the aft horizontal stabilizer spar; common to the rudder sector attach point, was torn and bent consistent with the wing impact. The rudder sector mount was torn from the structure at the fastener locations.

The rudder torque tube was fracture separated from the rudder control sector and the rudder. The upper and lower left and lower right rudder control cables were broken in a manner consistent with tensile overload. The upper right rudder control cable remained intact, but the ball end was pulled from the rudder sector. The autopilot rudder servo control cable was fractured in tensile overload. The left autopilot cable pulley bracket, with pully attached, was separated from the canted bulkhead. The left strake was impact fractured from the tail cone stinger and was recovered from the runway along with various sheet metal fragments from the stinger.

Figure 4. Left side view of N510HM's damage to its empennage.

Figure 5. Aft view of N510HM's damage to its empennage.

Figure 6. Right side view of N510HM's damage to its empennage.
